FINAL REPORT
SEPTEMBER 1989

REPORT NO. EVT 31-89

EVALUATION OF THE
RAILROAD BOXCAR LADING
STRAP ANCHORS ADAPTABLE TO
1 1/4-INCH STEEL BANDING

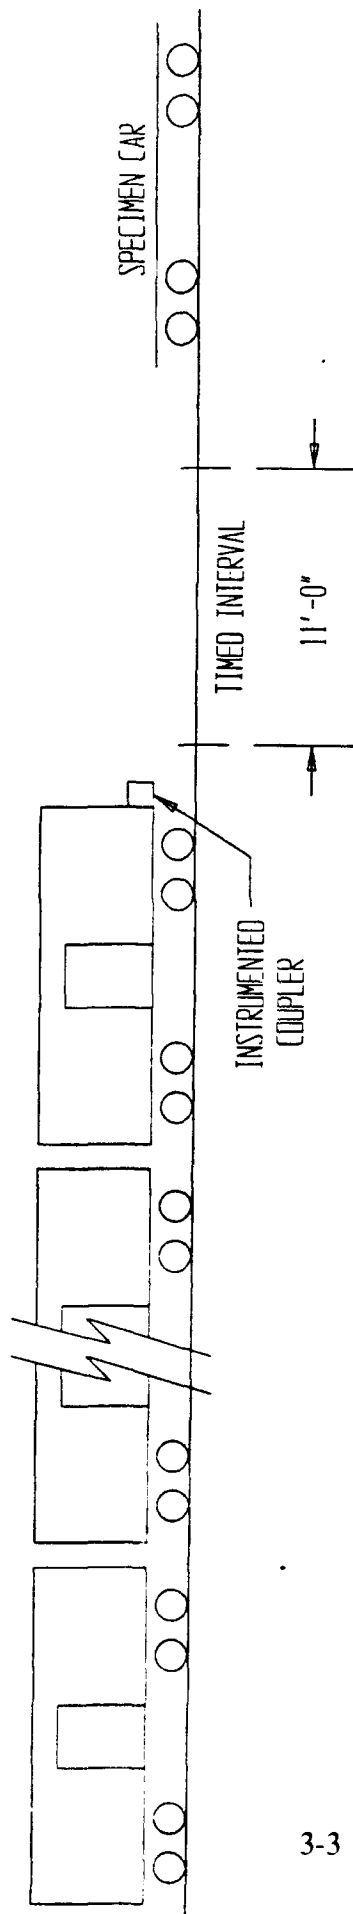
FIGURE 1

ASSOCIATION OF AMERICAN RAILROADS (AAR) STANDARD TEST PLAN

SPECIMEN CAR
IS RELEASED BY
SWITCH ENGINE TO
ATTAIN: IMPACT NO. 1 @ 4 MPH
IMPACT NO. 2 @ 6 MPH
IMPACT NO. 3 @ 8 MPH

5 BUFFER CARS (ANVIL) WITH DRAFT GEAR
COMPRESSED AND AIR BRAKES IN A SET
POSITION
ANVIL CAR TOTAL WT 250,000 LBS (APPROX)

A. RAIL IMPACT TESTING. Rail impact testing was accomplished in compliance with previously approved and standardized testing procedures (as shown on page 3-3) and described as follows:

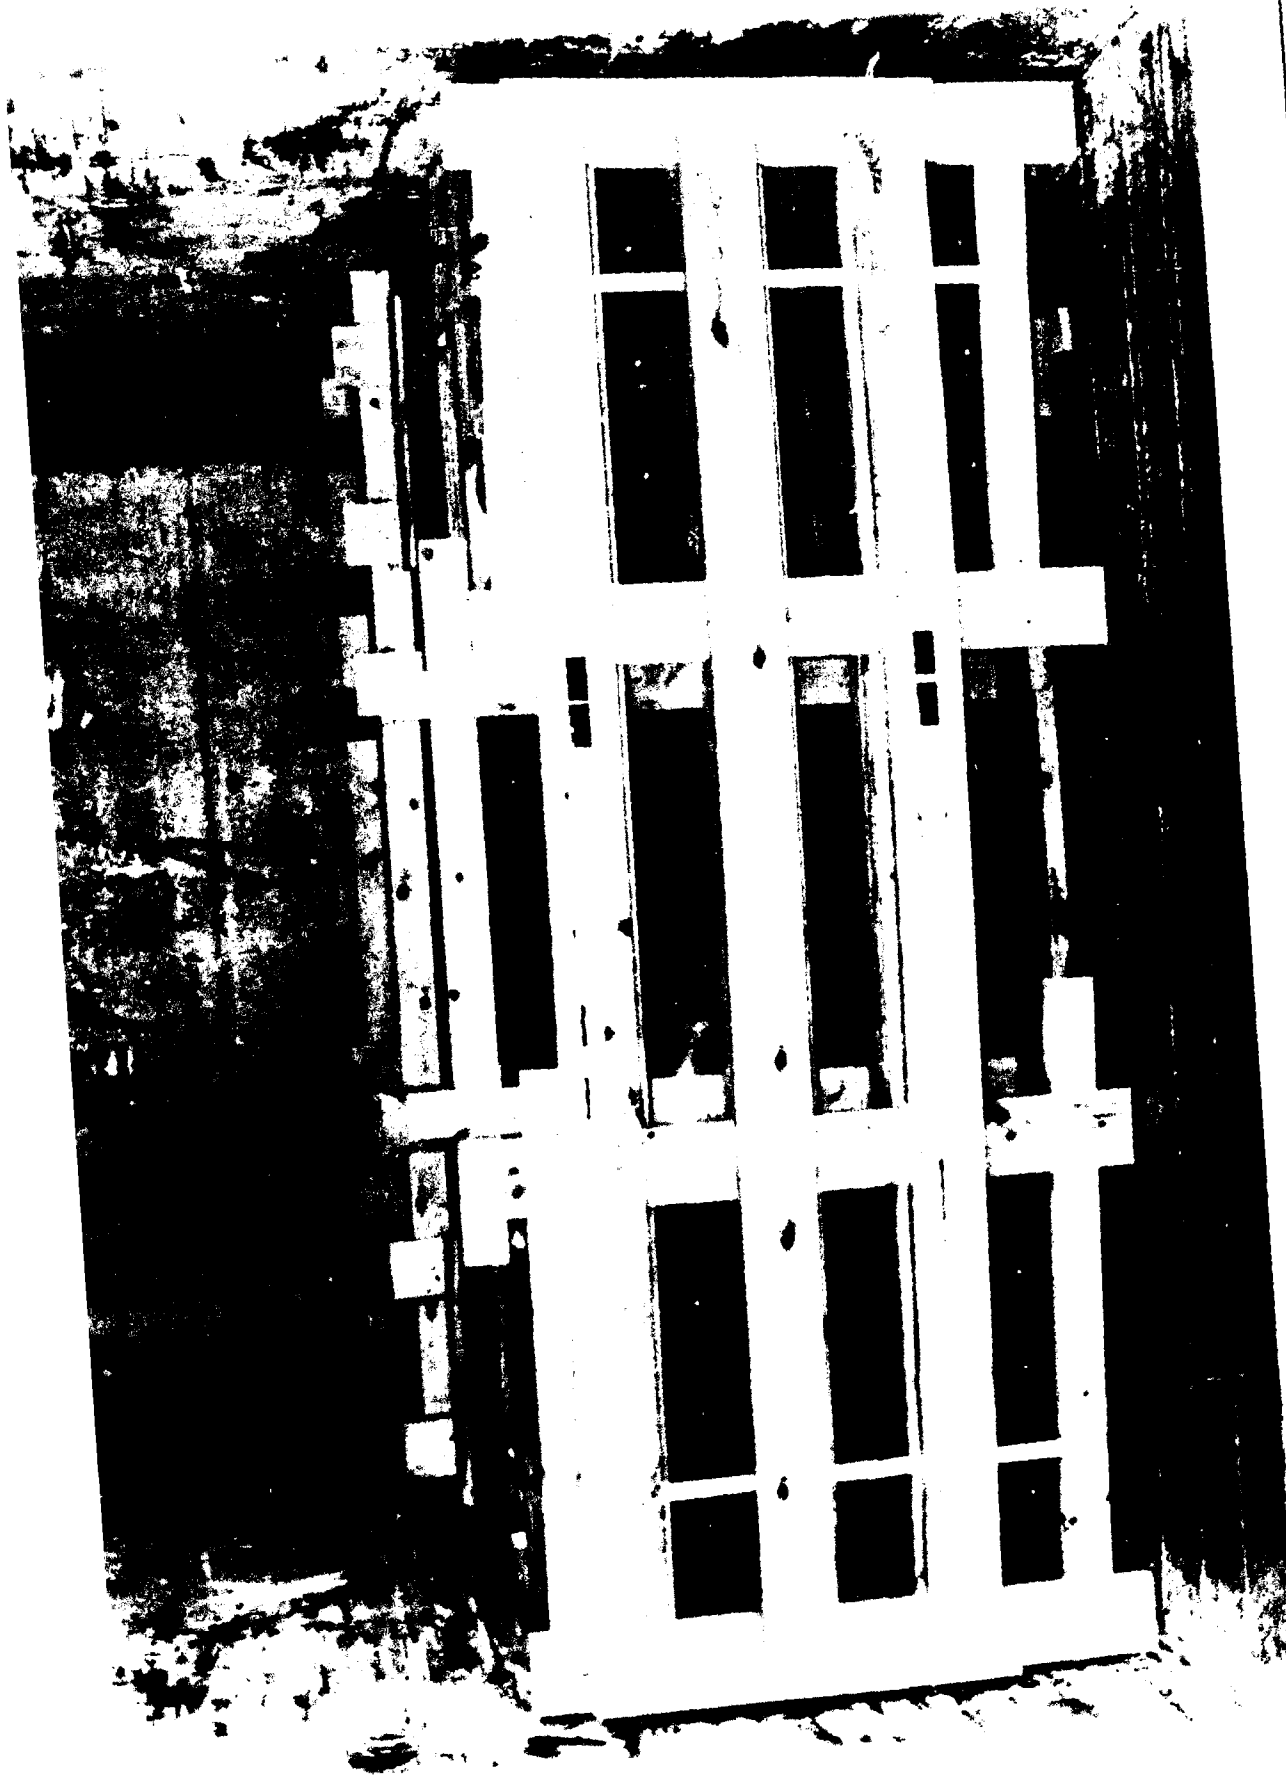
Photo No. AO317-SPN-89-962-4188. View of the two 1 1/4-inch steel straps across the strapping gate restraining the six pallets of propelling charges.

The test load of six pallets of propelling charges, one layer high and two rows wide, weighing 10,330 pounds, was secured in the "A" end of boxcar RBOX 40247. The load was restrained by two 1 1/4-inch steel straps doubled across the face of the strapping bulkhead gate.

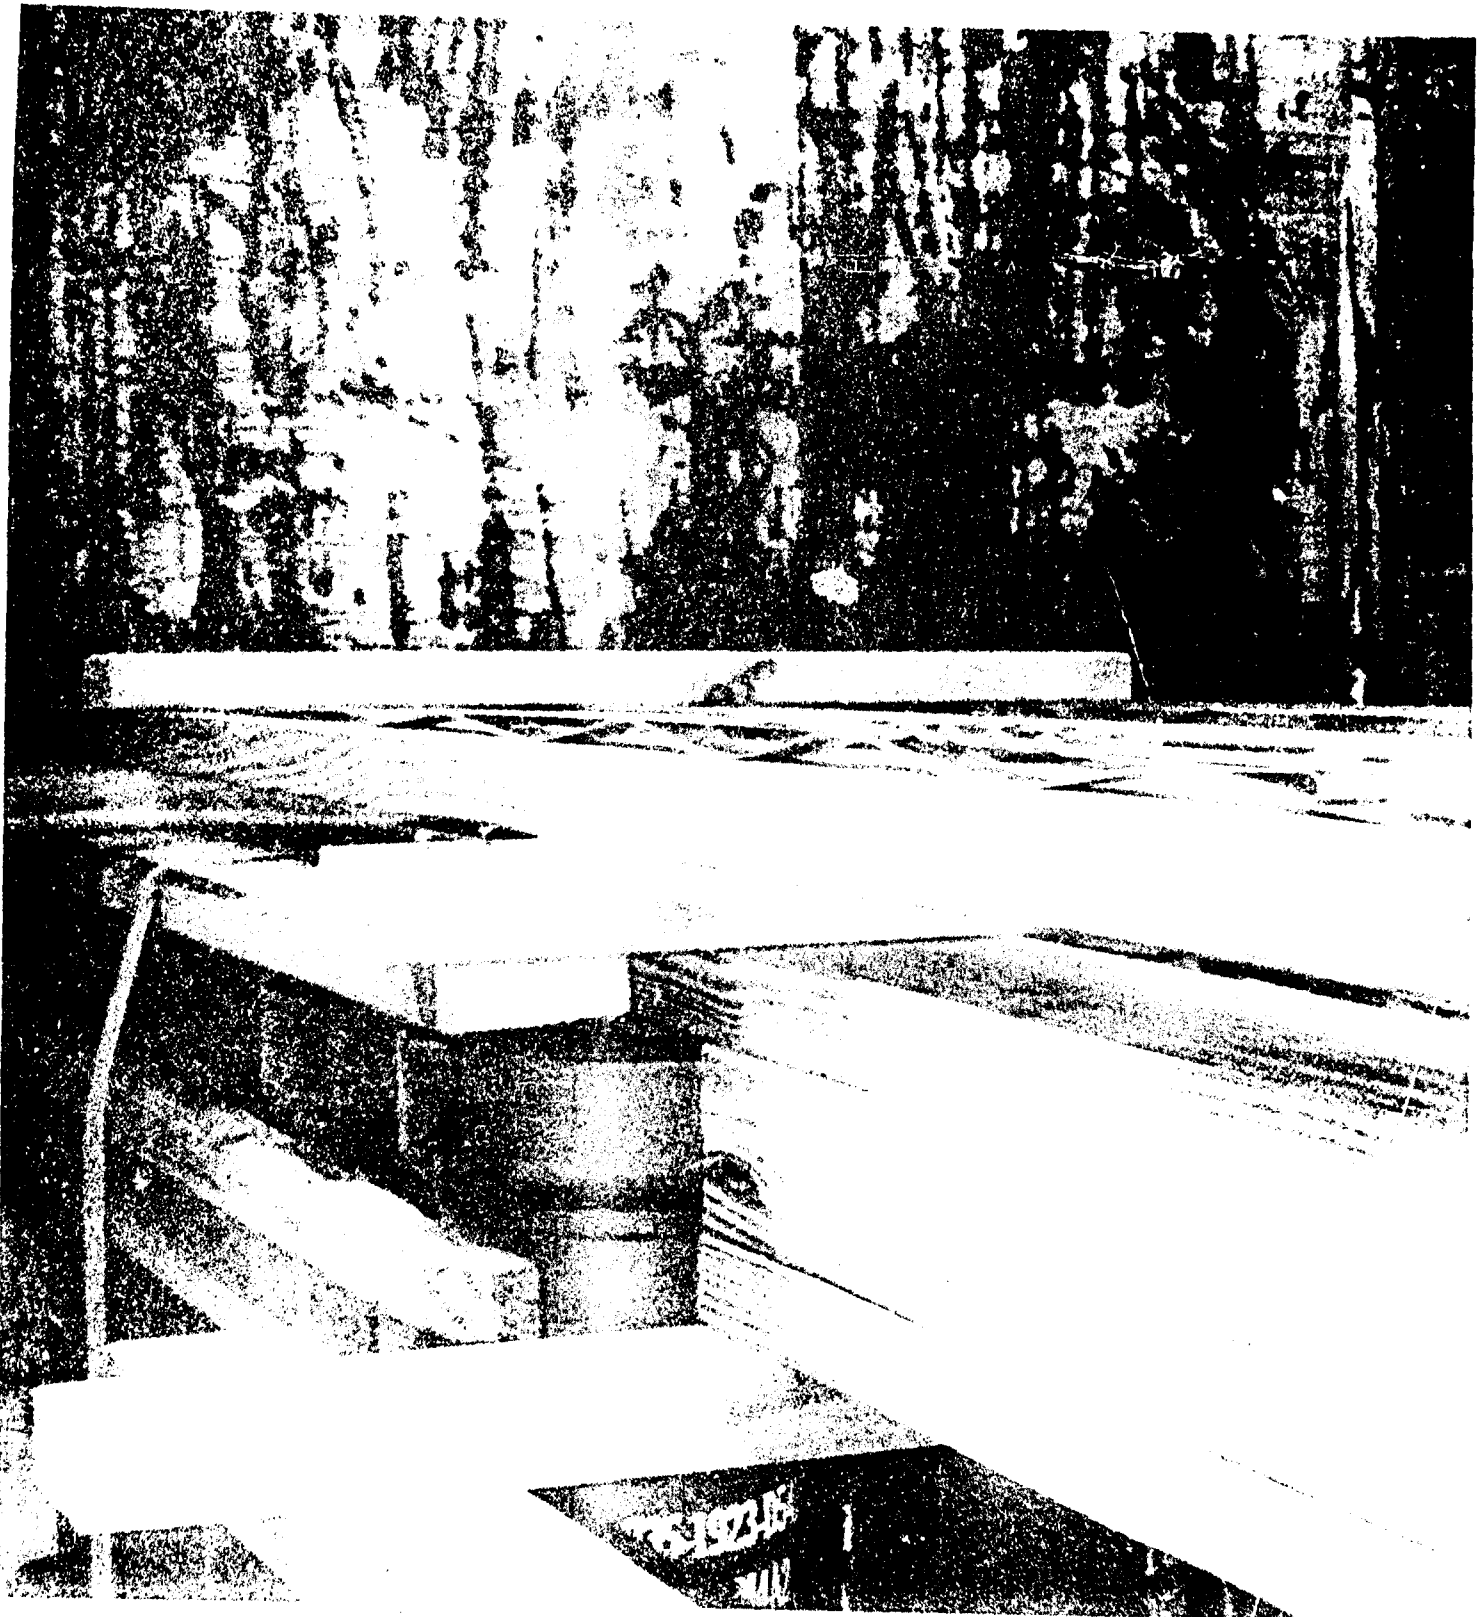
Each bulkhead steel strap consisted of two pieces. Each piece was threaded through the railroad boxcar strap anchor device, and the strap secured at the anchor point with a seal located 18 inches from the anchor device. The inside strap from each side was tensioned and sealed across the face of the bulkhead at both elevations before the second strap was tensioned and sealed. Tensioning the outer strap over the already sealed inner strap caused the inner strap to buckle and become slack.

Photo No. AO317-SPN-89-3783. View of the top 1 1/4-inch steel strap showing how the inner strap of the loop was not taut and buckled when the outer strap of the loop was tensioned.

The only change from Test No. 1 was the seal of the looped strap located 18 inches from the anchor device in the boxcar sidewall was not used. The intent in eliminating these seals was to permit the steel strap to feed or flow through the strap anchor device in the sidewall, equalizing the tension in each strap of the loop that extends across the face of the strapping bulkhead gate.

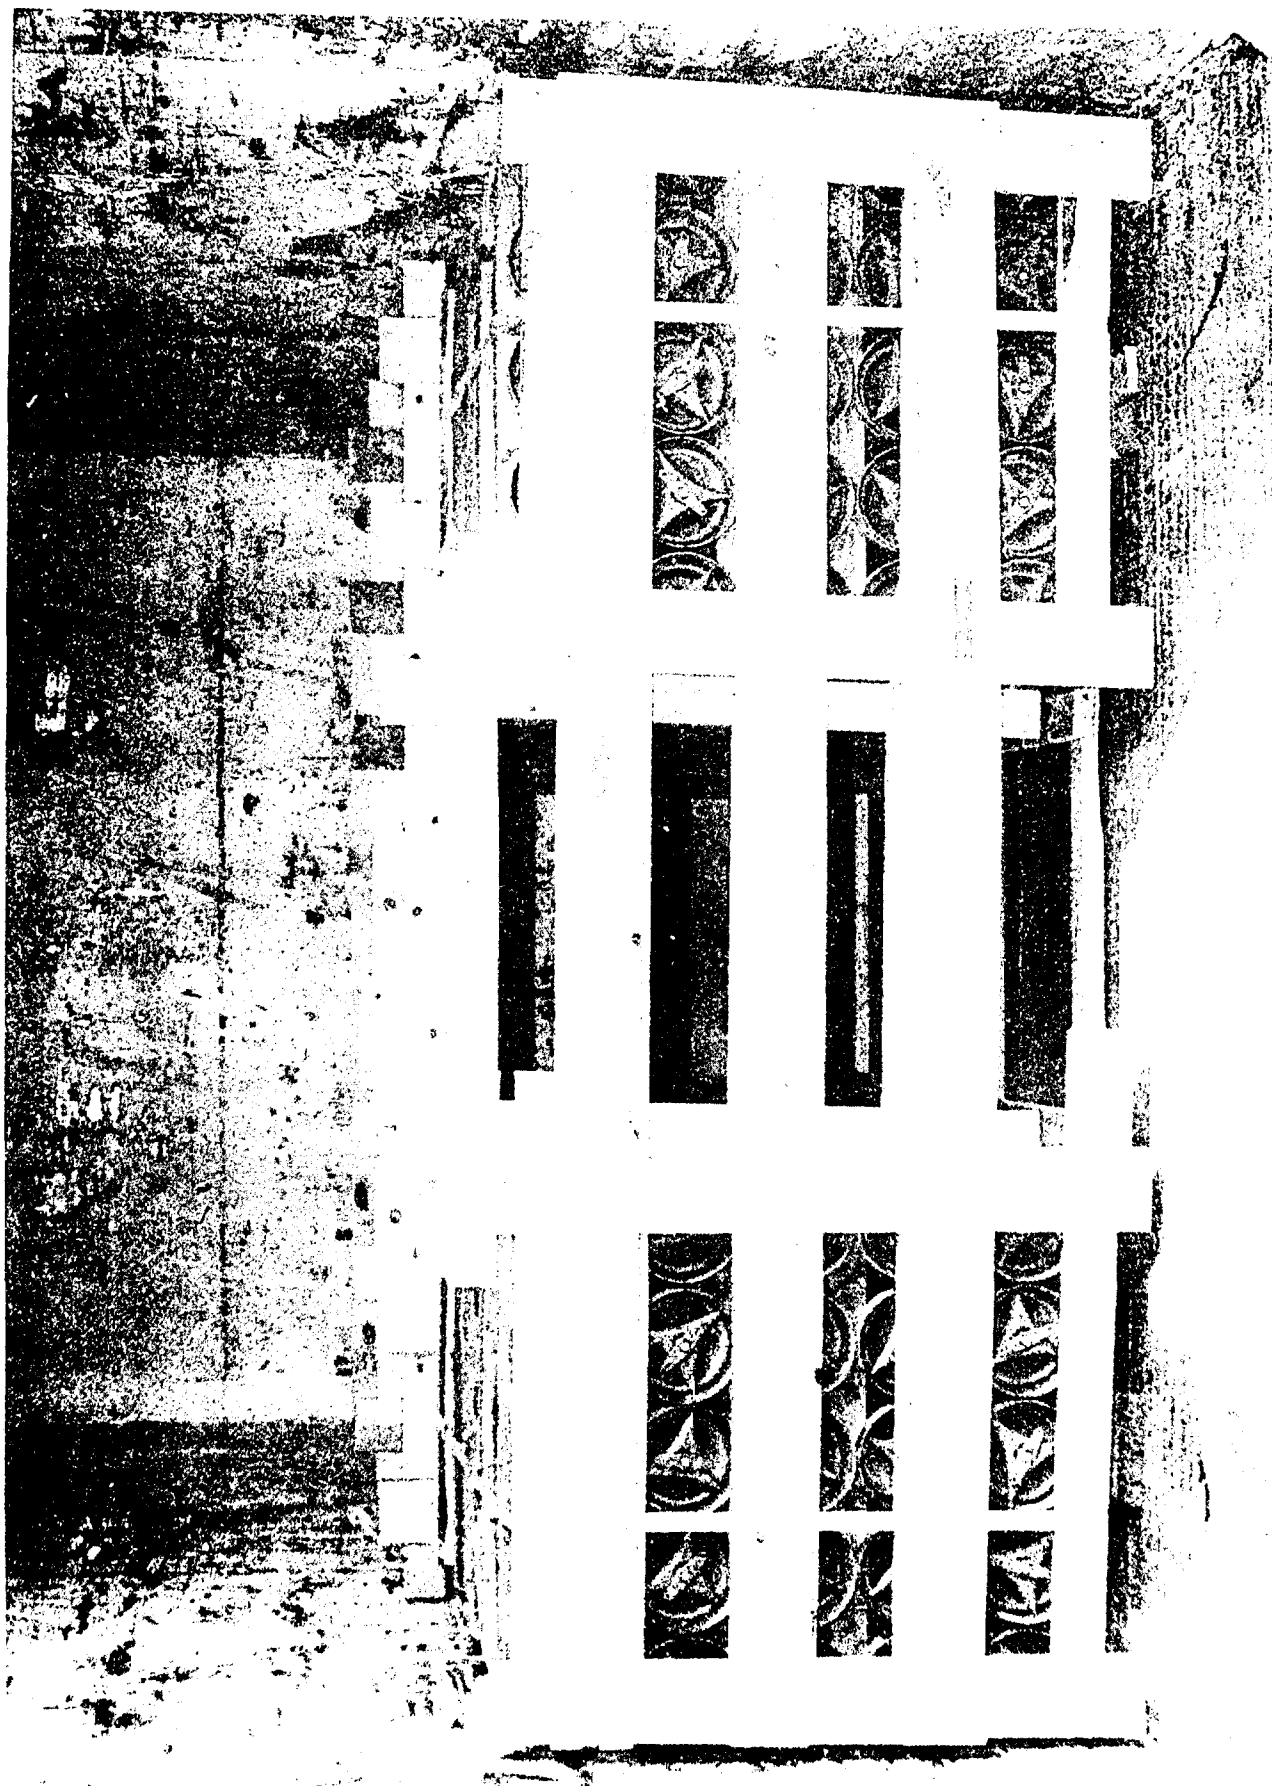
Photo No. AO317-SPN-89-3775. View of the 1 1/4-inch steel straps across the strapping gate restraining the six pallets of propelling charges.

The test load configuration of six pallets of propelling charges remained the same for this test. The load was restrained by two 1 1/4-inch steel straps doubled across the face of the strapping bulkhead gate.

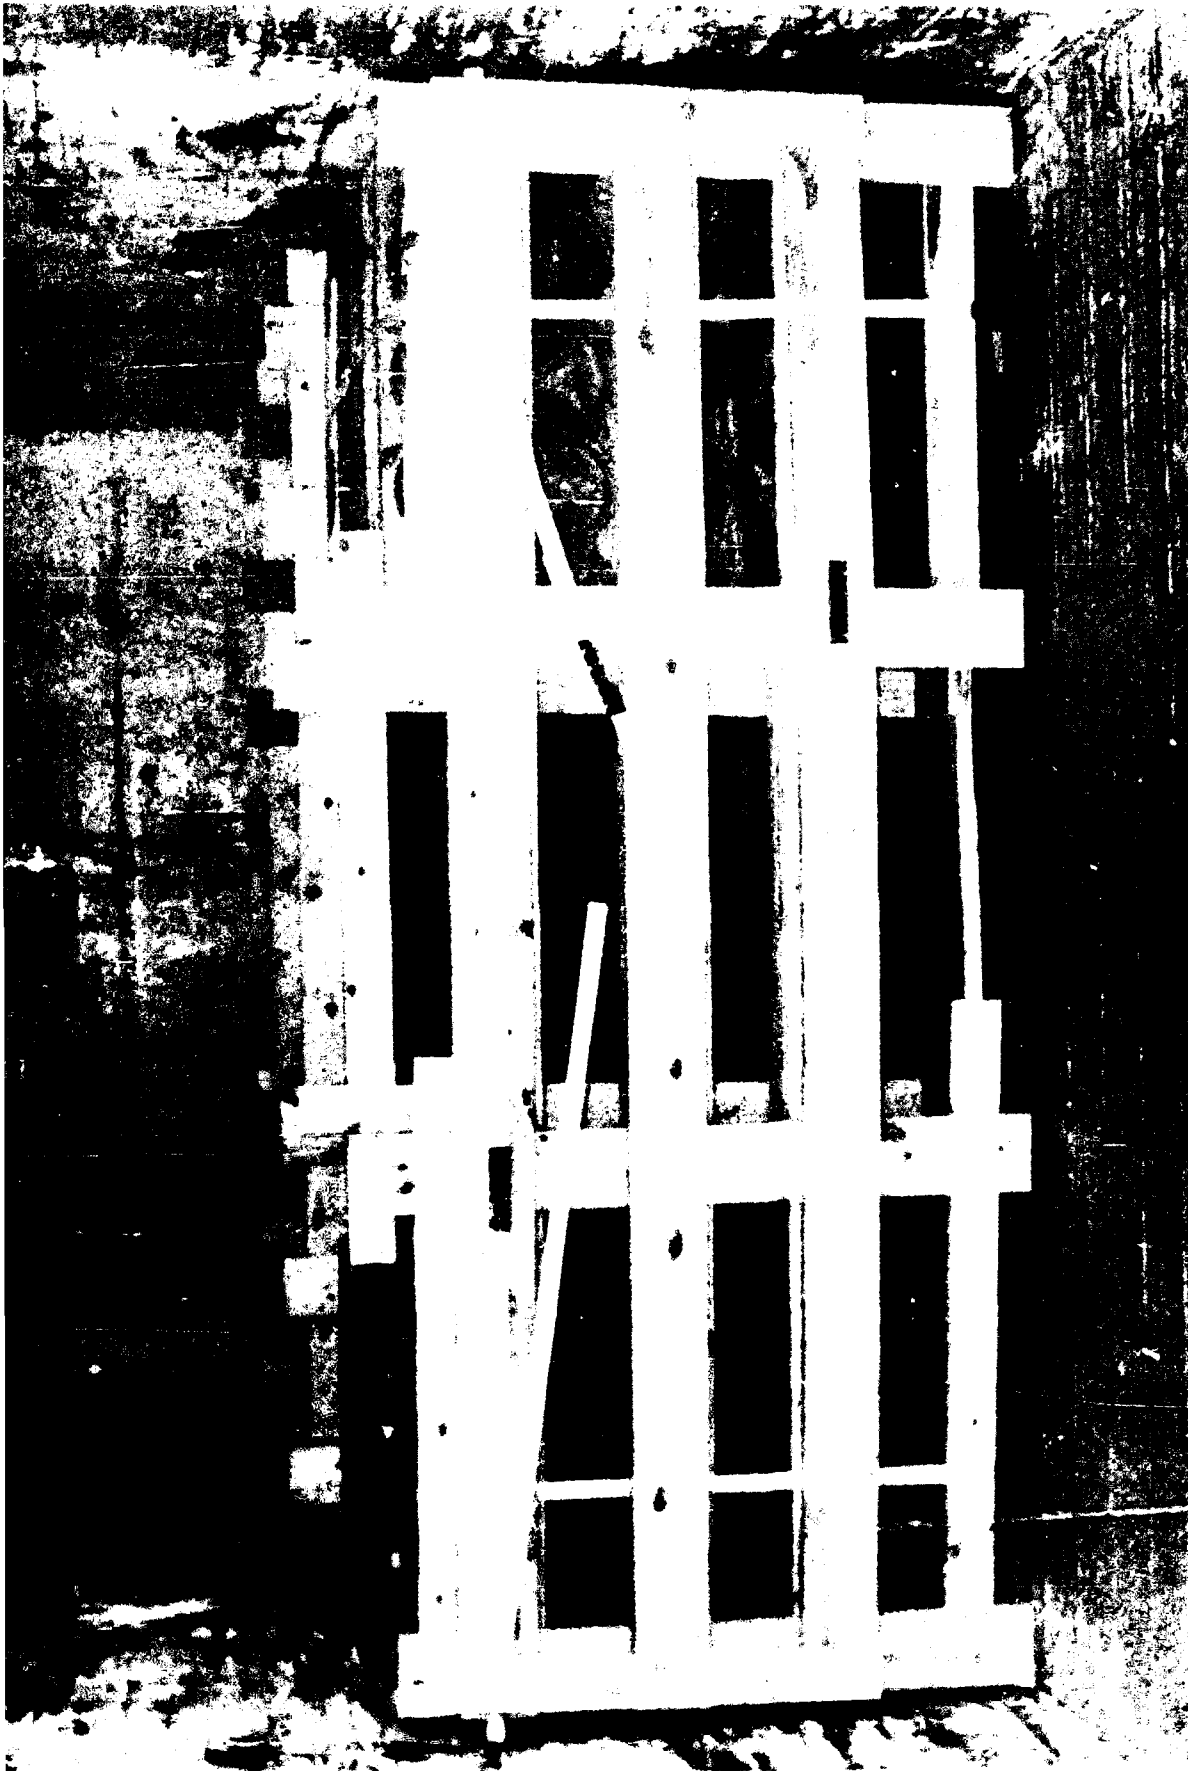
The 4 and 6 mph rail impacts were again uneventful. The third impact at 7.86 mph resulted in the upper steel strap failing at the crimp in the seal. The bottom strap loop did not fail, and both straps of the bottom loop remained in nearly equal tension.

Photo No. AO317-SPN-89-3781. View of the failed upper strap during the 8 mph rail impact.

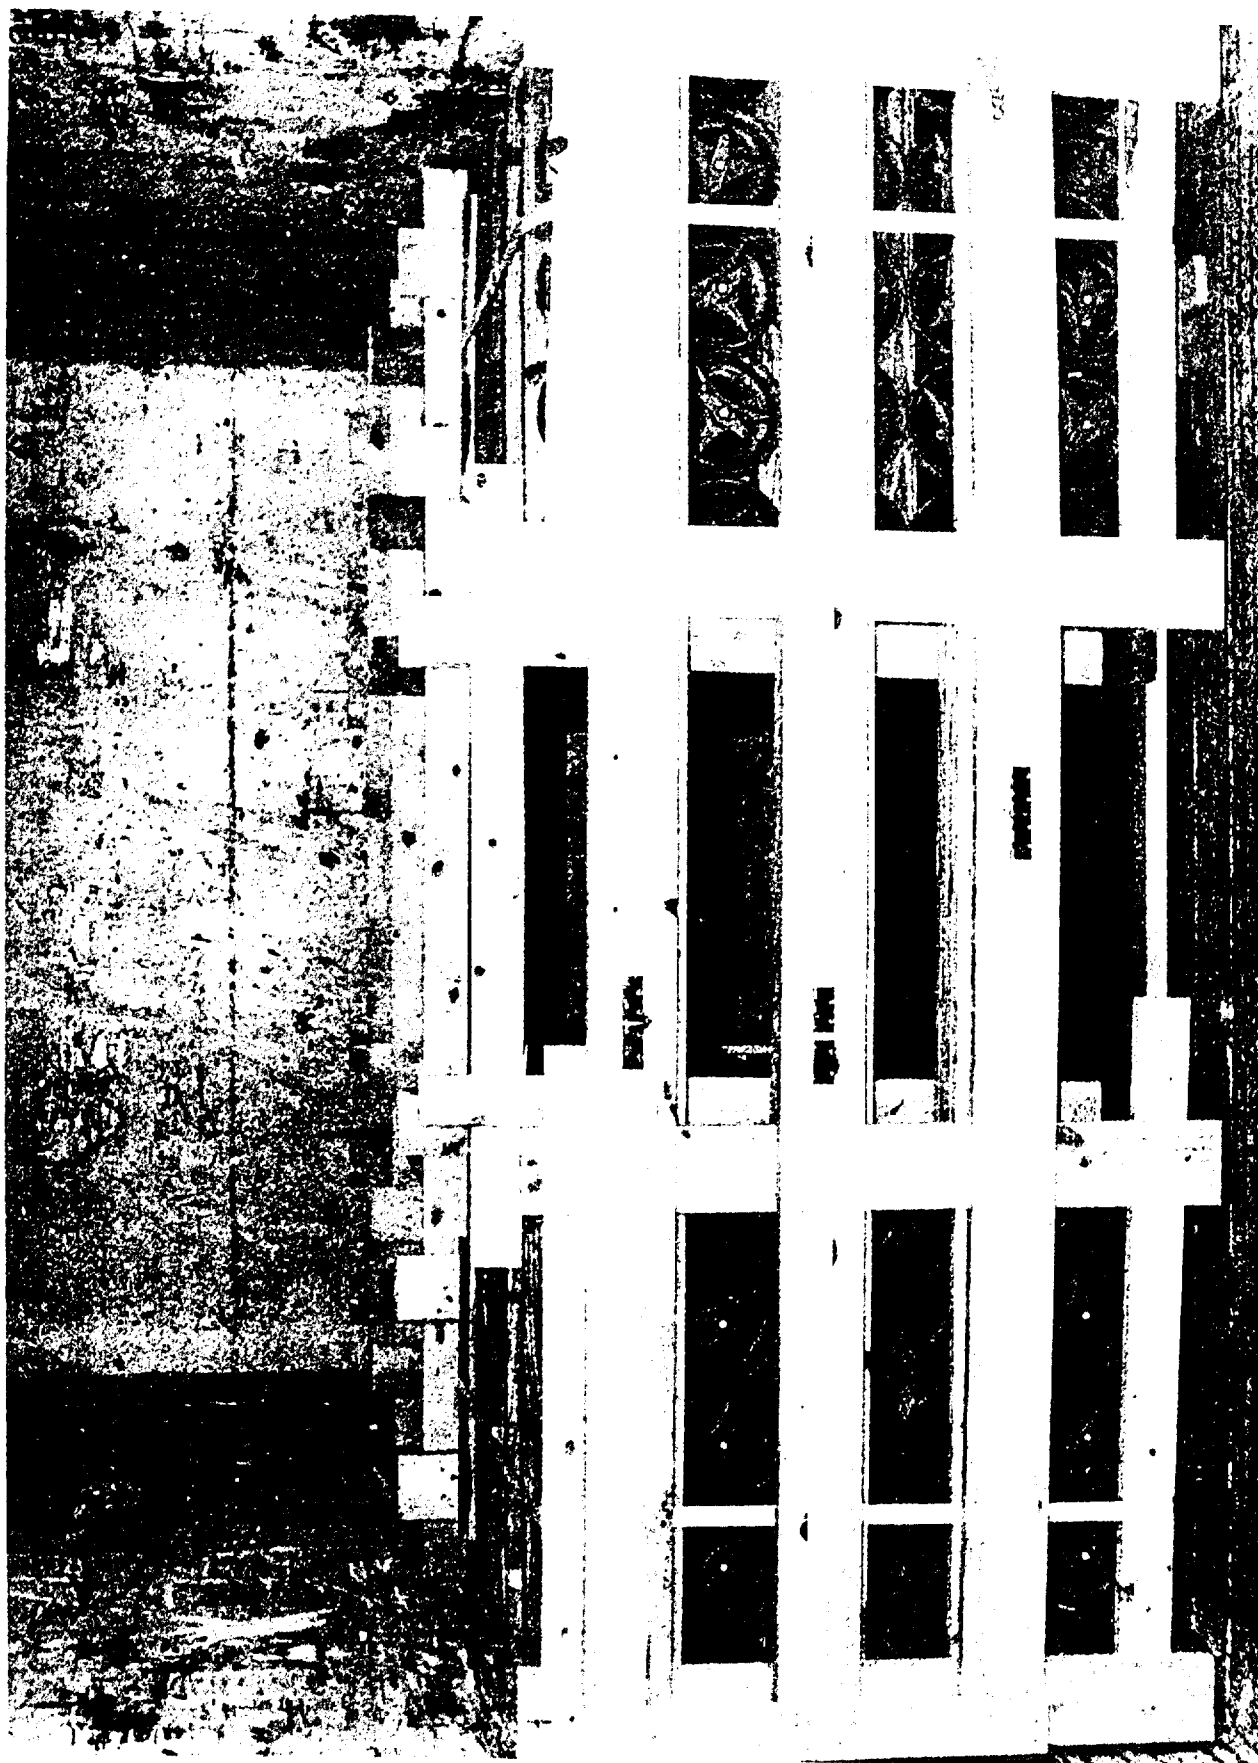
During the second rail impact at 6.24 mph, the lowest steel strap failed at the notch in both seals located adjacent to each strap anchor device in the boxcar sidewall. The upper two steel straps were not damaged.

Photo No. AO317-SPN-89-3787. View of the three 1 1/4-inch steel straps across the strapping gate restraining the six pallets of propelling charges.

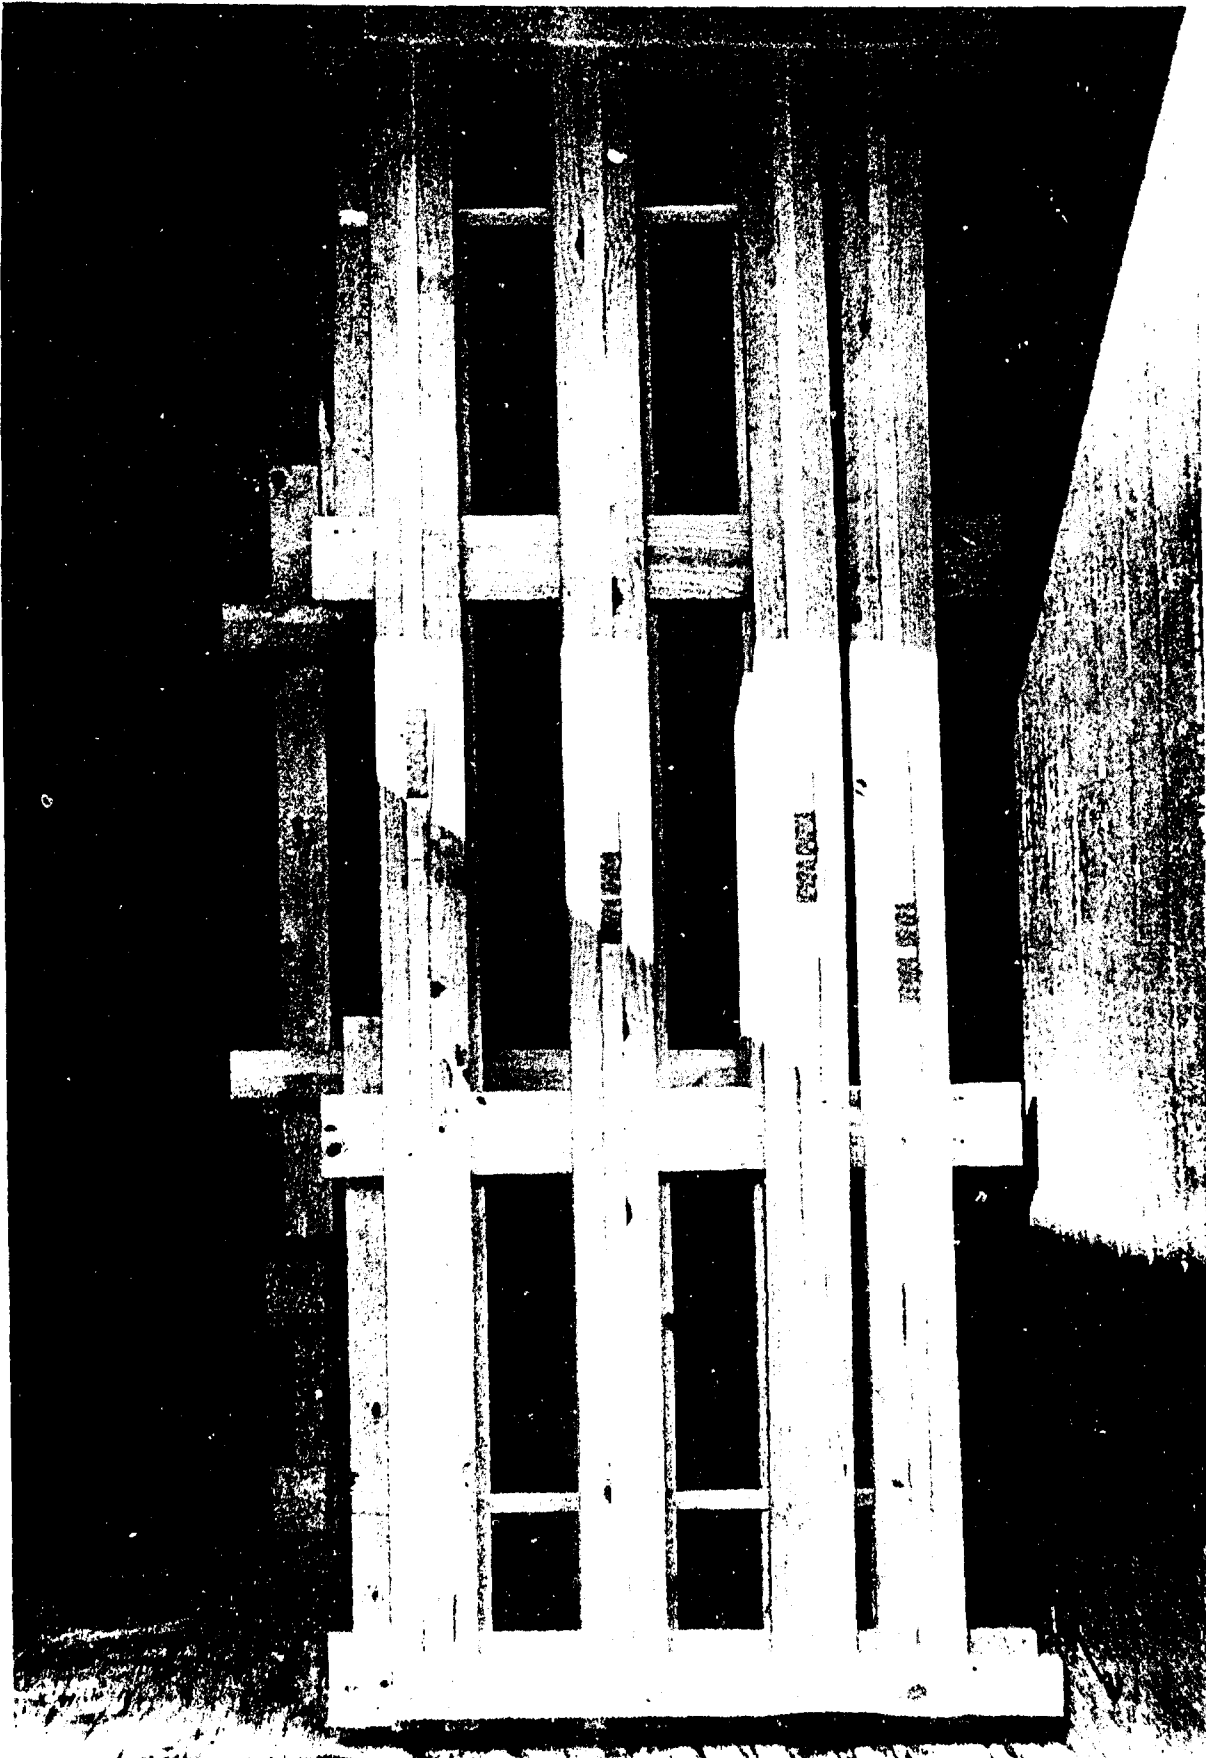
During the third rail impact at a speed of 8.08 mph, all four steel straps failed when the strap broke at the notch in the seal located 12 inches from the anchor device. The six pallets moved six inches forward, after the four steel straps separated.

Photo No. AO317-SPN-89-3732. View of the four 1 1/4-inch steel straps across the strapping gate restraining the six pallets of propelling charges.

3. Recommend the AAR/BOE's required 36 inches from the lading strap anchor to the face of the load be reduced to 33 inches needed for the reduced load restrained by the 1 1/4-inch strapping.

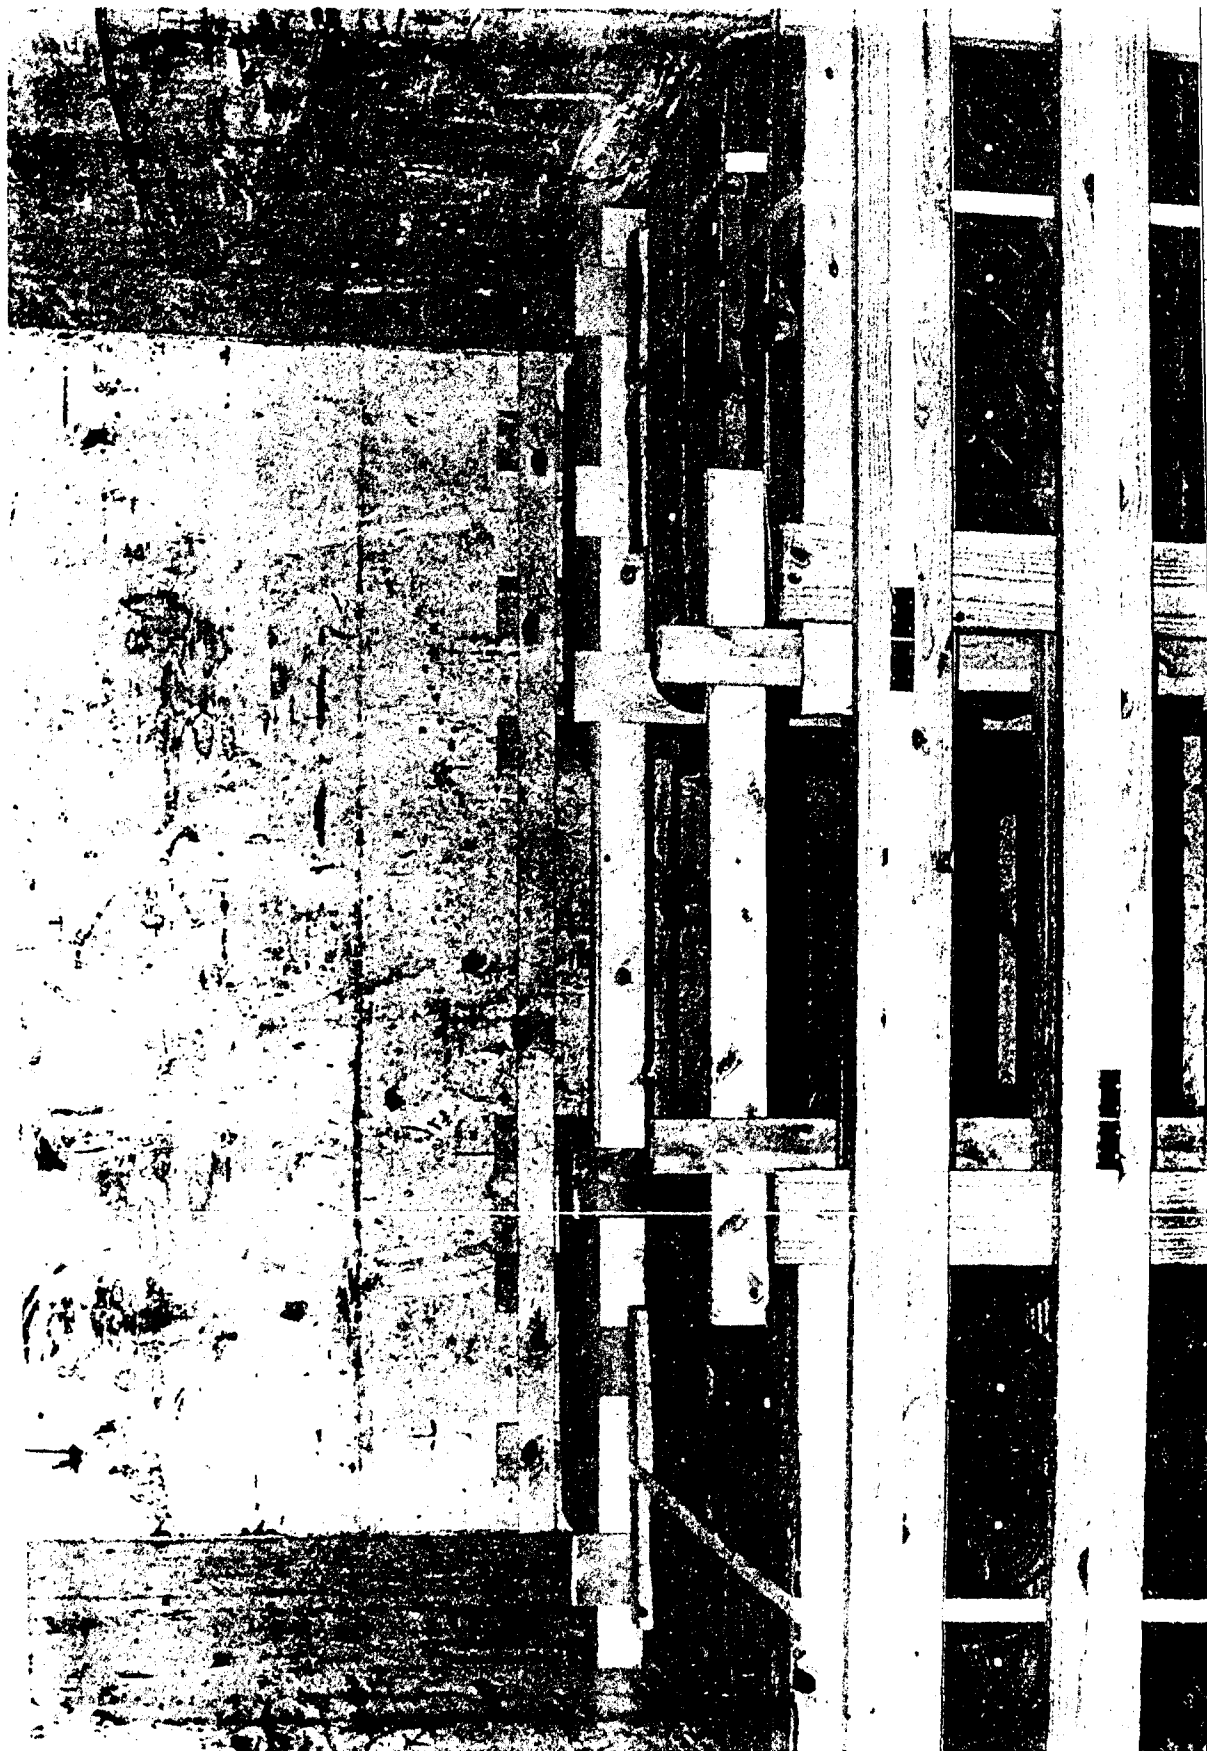
The rail impacts of 4,6, and 8 mph were performed with accumulated movement at the center of the strapping bulkhead gate of less than 1/2-inch. The four 1 1/4-inch steel straps restrained the 6,890-pound load.

Photo No. AO317-SPN-89-962-4193. View of the top two 1 1/4-inch steel straps of the four 1 1/4-inch straps used to restrain the four pallets of propelling charges.

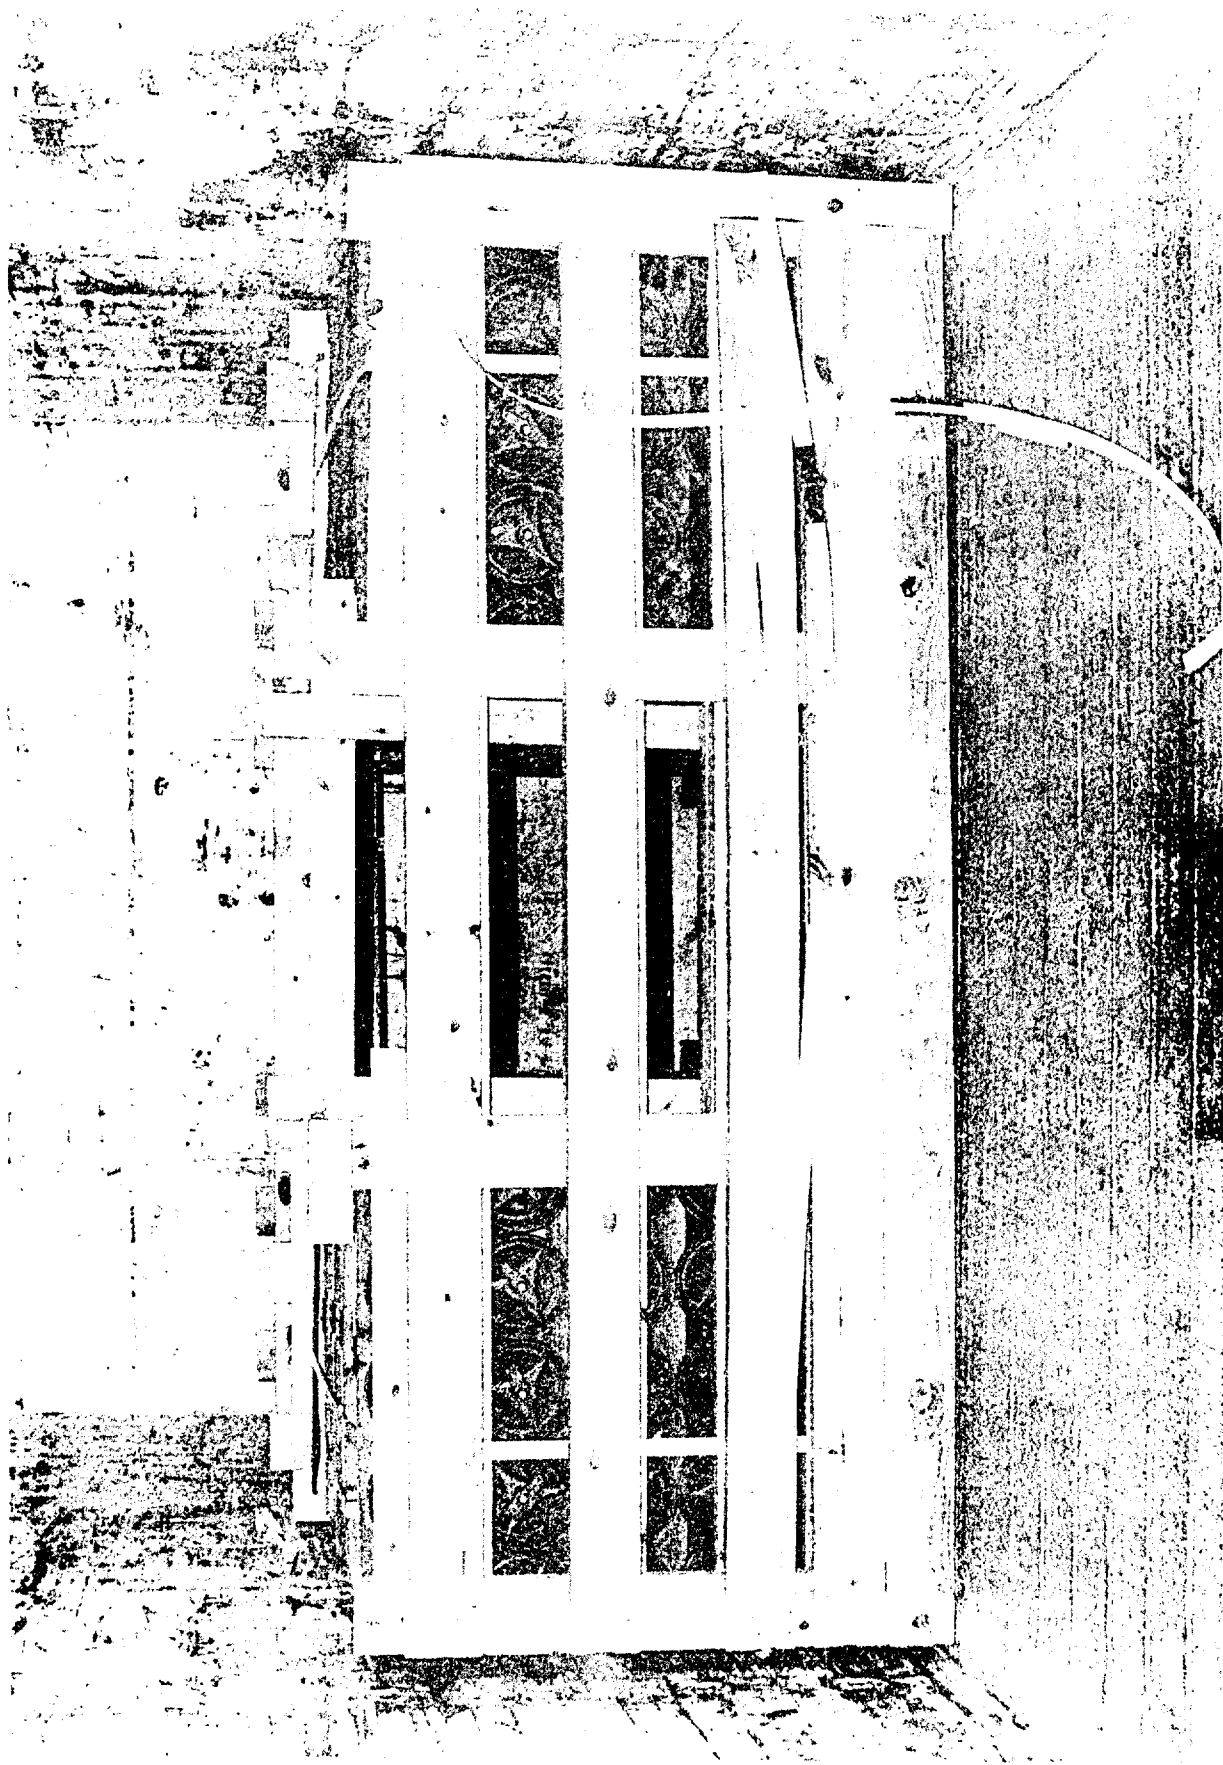
The load did not move during the 4.24 mph rail impact. The 6.10 mph rail impact resulted in the strapping gate rebounding 3/16-inch at the gate's center. The 8 mph rail impact was not measured, but it appeared to be close to the desired speed. Both remaining 1 1/4-inch steel straps failed through the crimp in the strap.

Photo No. AO317-SPN-89-692-4191. View of the failure of both of the 1 1/4-inch steel straps following the 8 mph rail impact. Note: The strap was not doubled across the strapping gate.

2. Recommend that a bulkhead gate used in combination with two bands of 1 1/4-inch steel strapping not retain more than 4,500 pounds of load in a railroad boxcar.
